Manhole Inspection Summary

Manhole # S45KK_030MH

Location Address: **E Lanvale St**

Cross Street: **Washington St**

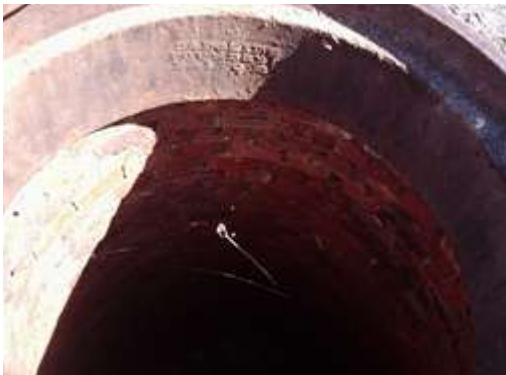
Defect 1

Offset: **1** (in.)

☒ **Leaks**

frame leaks

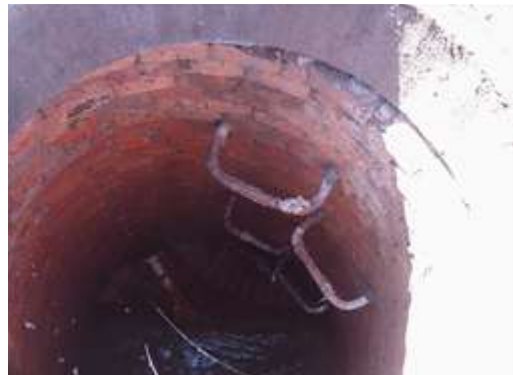
Defect 2

Condition: ☐ Sound ☐ Cracked ☐ Root Intrusion ☐ Loose Brick ☒ **Deteriorated**

Infiltration: ☐ None ☒ **Joint** ☐ Cracks ☐ Mortar ☐ Roots ☐ Wall

brick detraction

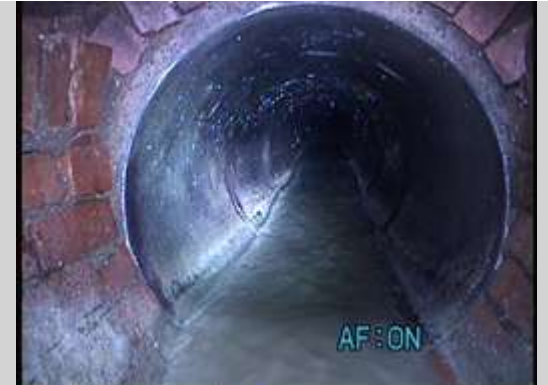
12 O'Clock Outflow

21 in. Circular Gravity Sewer
Pipe Out @ 12 O'Clock

Pipe Height: **21.6** (in.) Rod and Bar (Angled)
Pipe Material: **Clay** ☐ Pipe Lined
Invert Depth: **10.90** (ft.) Flow Characteristics: **Fast**
Deposits: ☒ None ☐ Mud ☐ Sludge ☐ Debris ☐ Grease
Silt Depth: (in.) Deposits Extent:
Infiltration: **None** Pipe Seal Cond: **Sound**

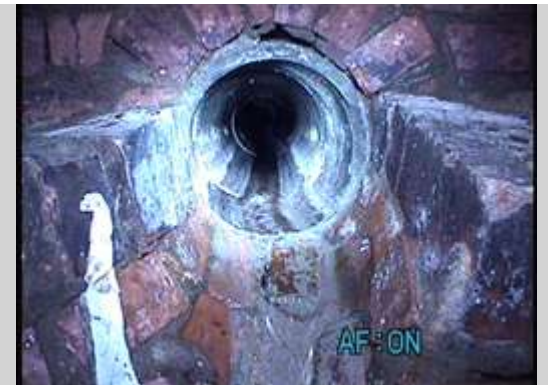
3 O'Clock Inflow

8 in. Circular Gravity Sewer
Pipe In @ 3 O'Clock

Pipe Height: **8.4** (in.) Rod and Bar (Angled)
Pipe Material: **Clay** ☐ Pipe Lined
Invert Depth: **9.60** (ft.) Flow Characteristics: **Fast**
Deposits: ☒ None ☐ Mud ☐ Sludge ☐ Debris ☐ Grease
Silt Depth: (in.) Deposits Extent:
Infiltration: **None** Pipe Seal Cond: **Sound**

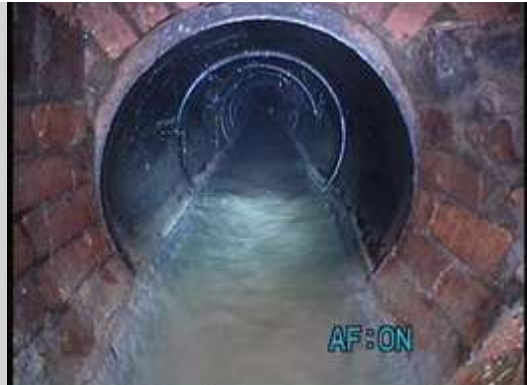
6 O'Clock Inflow

Pipe Height: **21.6** (in.) Rod and Bar (Angled)

Infiltration: **None** Pipe Seal Cond: **Sound**

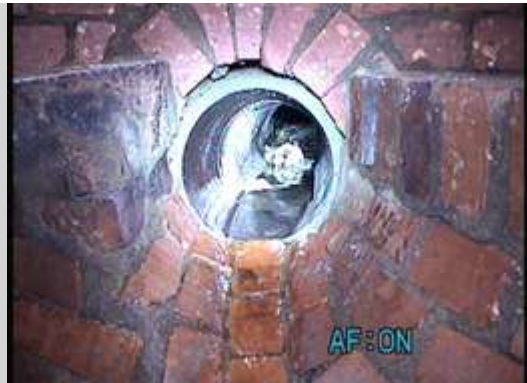
9 O'Clock Inflow

Pipe Height: **8.4** (in.) Rod and Bar (Angled)

Infiltration: **None** Pipe Seal Cond: **Sound**
